Appendix E Photograph Log

Inspection Dates: May 15-16, 2012

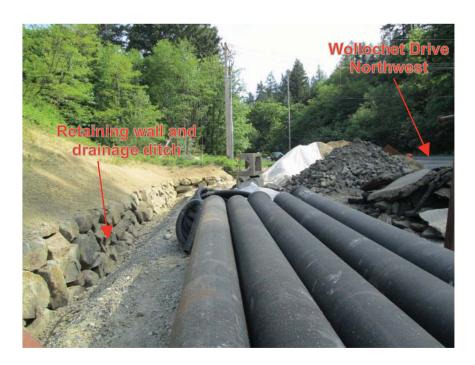
Photograph 1. County Road Project No. 5696 – View of staging area located northeast of the Wollochet Drive Northwest and East Bay Drive Northwest intersection.

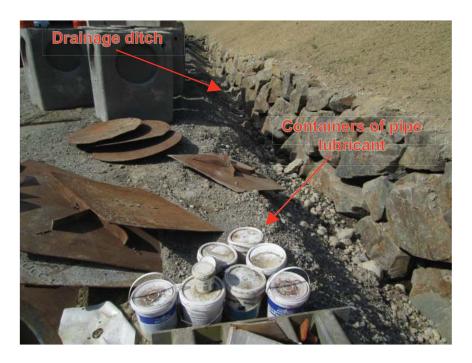
Photograph 2. County Road Project No. 5696 – Containers of pipe lubricant stored outdoors without coverage or containment BMPs.

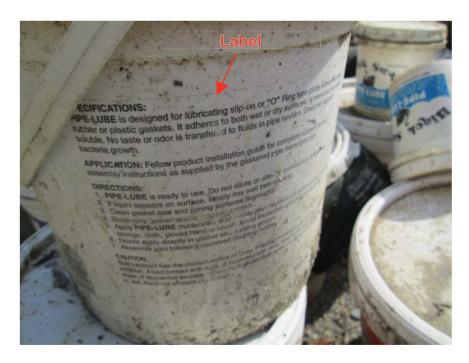
Photograph 3. County Road Project No. 5696 – Close-up view of label on pipe lubricant.

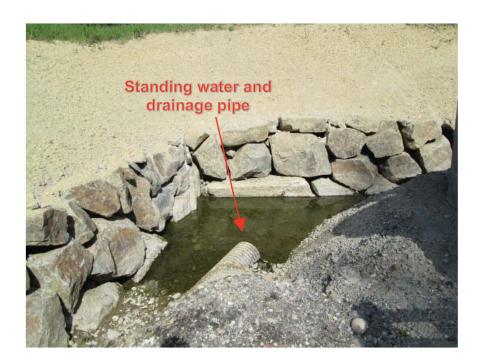
Photograph 4. County Road Project No. 5696 – View of standing water in the drainage ditch at the southwest corner of the staging area. Note that the drainage pipe conveys flow under Wollochet Drive Northwest.

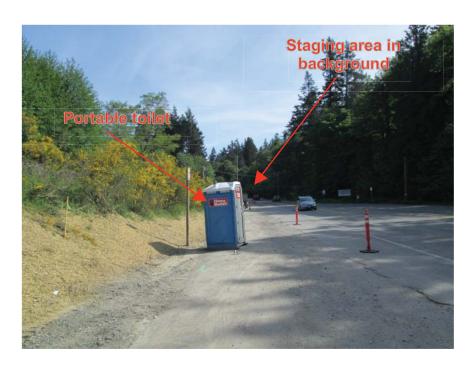
Photograph 5. County Road Project No. 5696 – View of portable toilet southwest of the staging area along Wollochet Drive Northwest.

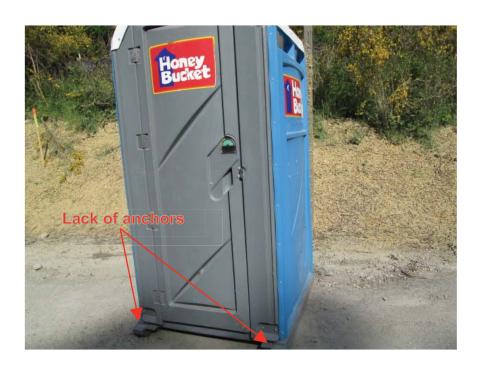
Photograph 6. County Road Project No. 5696 – Close-up view of portable toilet that was not properly secured.

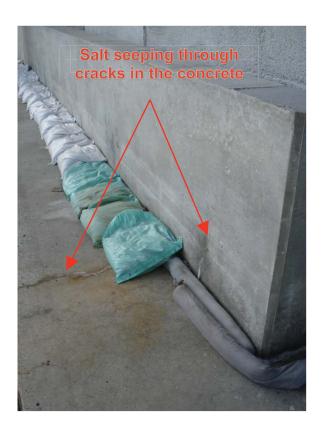
Photograph 7. Central Maintenance Facility – View of sand bags and absorbent socks around base of containment for salt storage. Note salt seeping through cracks.

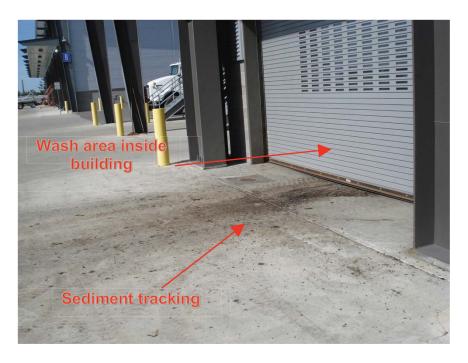
Photograph 8. Central Maintenance Facility – View of sediment tracking outside the Equipment Services Division's wash area.

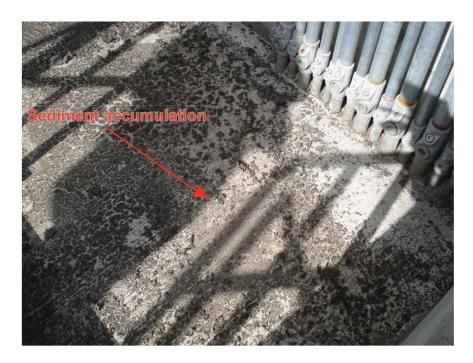
Photograph 9. Central Maintenance Facility – View of sediment accumulation inside the asphalt emulsion containment area.

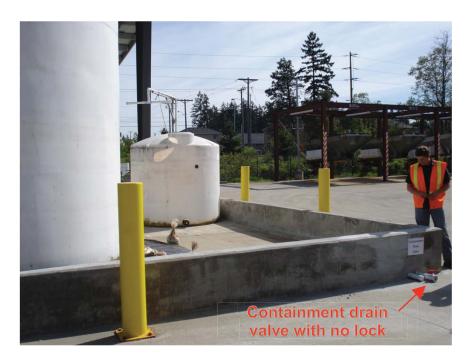
Photograph 10. Central Maintenance Facility – View of containment drain valve without a lock at the secondary containment for the brine tanks.

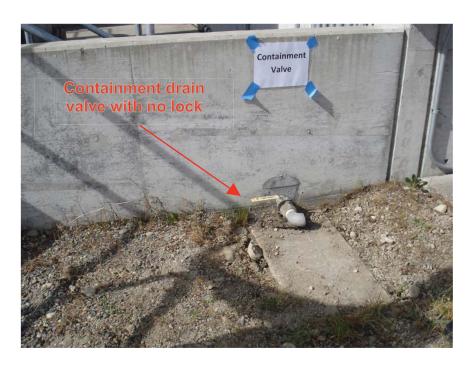
Photograph 11. Central Maintenance Facility – View of containment drain valve without a lock at the secondary containment for the asphalt emulsion tanks.

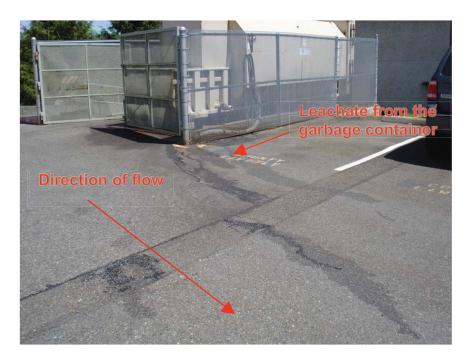
Photograph 12. Remann Hall Juvenile Facility – View of leachate fromt the garbage container on the west side of the Facility.

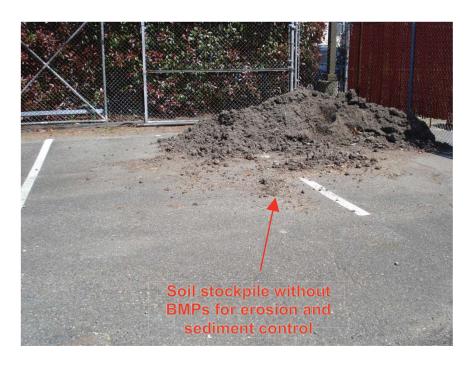
Photograph 13. Remann Hall Juvenile Facility – View of soil stockpile without BMPs for erosion and sediment control in the parking lot near Progress House.

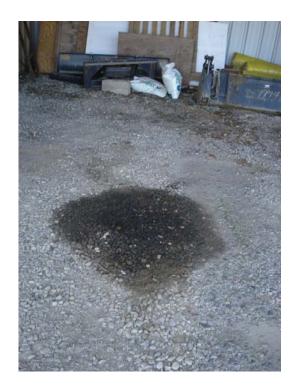
Photograph 14. Remann Hall Juvenile Facility – Close-up view of oil staining in the vehicle and equipment maintenance and storage area.

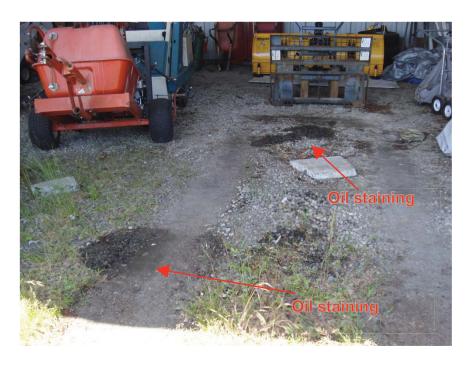
Photograph 15. Remann Hall Juvenile Facility – View of oil stains in the vehicle and equipment maintenance and storage area.
